## Condition Report on the Organ

### + Christ King Catholic Parish +

October 2014

**ORGAN STOPLIST AND CONDITION SURVEY REPORT:**

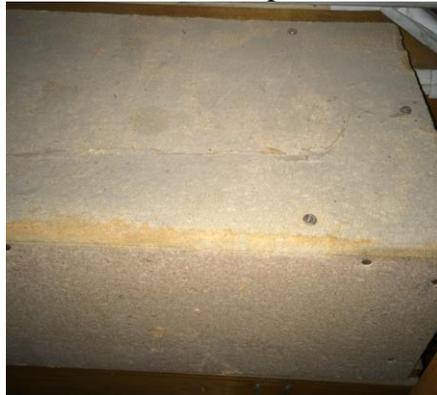
- a. Soft wood material construction: screws strip out easily, construction is not dimensionally stable; plywood delaminates and leaves debris particles in the valve system

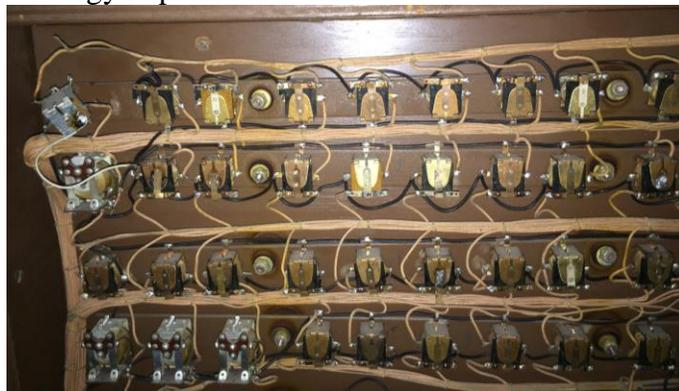
- b. Electrical system: Phosphor bronze contacts corrode and burn easily. There is no spark suppression methodology to protect contacts.

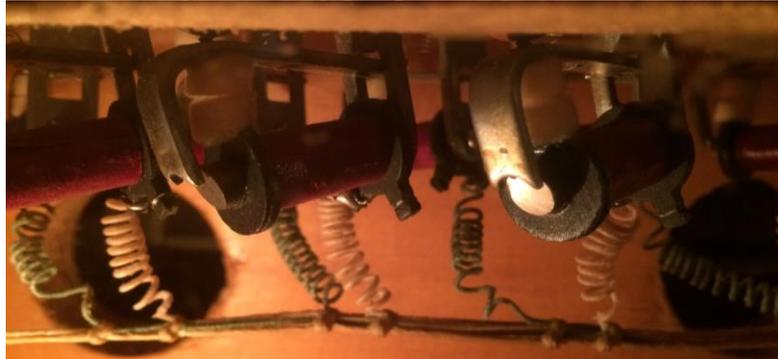
- d. The direct electric valve system can only operate on lower wind pressure; higher pressures are needed for stable tuning and reed pipe speech

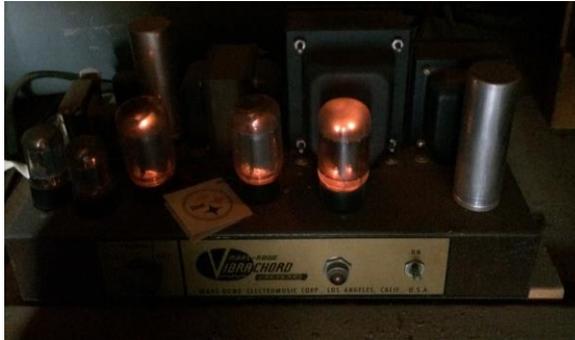
- a. Electrical system fire hazard

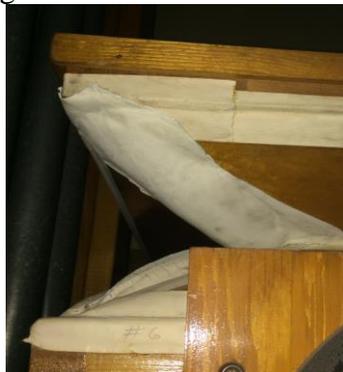
- b. Burnt key, pedal, and switch contacts
- c. Broken expression shoe contacts
- d. Loose pedal tension, and no means of increasing tension
- e. Too stiff keyboard tension
- f. Rotting and decayed bellows gusset leathers

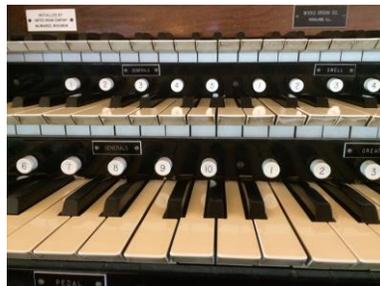
- g. Debris particles from decaying plywood clogging valves
- h. Sticking armature axels and hinge pins
- i. Corroded relay and switch contact rails
- j. Warped soft wood rails in switches that hold contact pins
- k. Broken down DC current generator
- l. Dead divisional cancel piston contacts

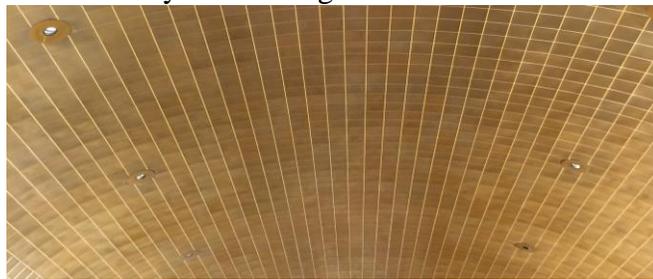
- a. Poor tonal and speech regulation for many pipes
- b. Unstable or impossible tuning due to pipe construction and poor initial regulation
- c. Un-responsive and inadequate wind regulators
- d. Valves that do not open to supply even and stable wind to pipes
- e. All sets of pipes are "duplexed/unified", such that they do not have dedicated, stable tonal functions
- f. The completely sound absorbing ceiling in the Nave of the church does not allow proper sound reflection, reinforcement or reverberation. Organ tone is severely diminished and tone projection is decimated by the existing room acoustic situation.
